Field Remedy: 1404

Subject: Door Check Spring - No function of door opening check

Speedster 2001...2002, VX220 2001...2002 Z22SE, Z22SE Non

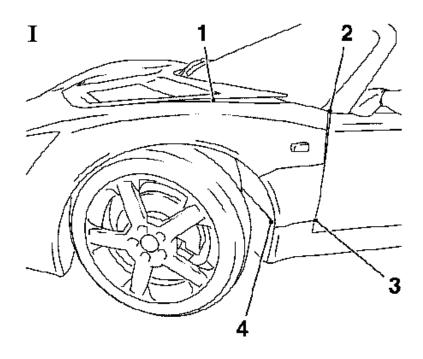
- 4. Separate turn signal light at front clamshell electrically.
- 5. Remove front clamshell fixings at A-pillar, 4 fastening screws (pic. I).

```
Pos. 1 = pic. II
Pos. 2 = pic. III
Pos. 3 = pic. IV
Pos. 4 = pic. V
```

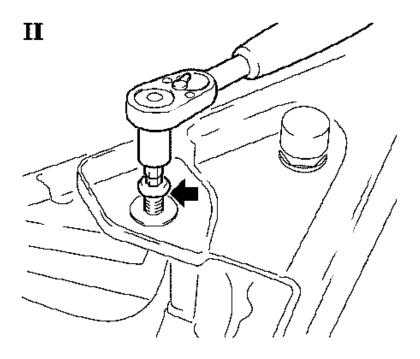
6. Remove screw at A-pillar (pic. II, arrow).

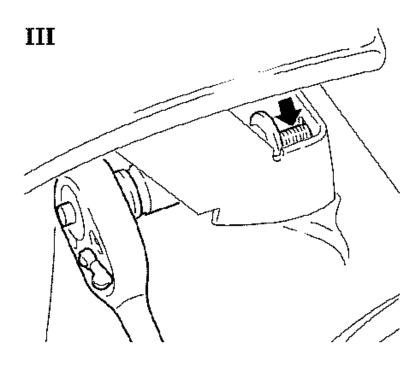
7. Remove screw at A-pillar (pic. III, arrow).

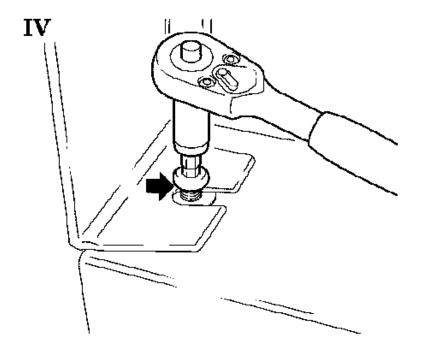
8. Loosen screw at wheel housing (slotted mounting) (pic. IV, arrow).

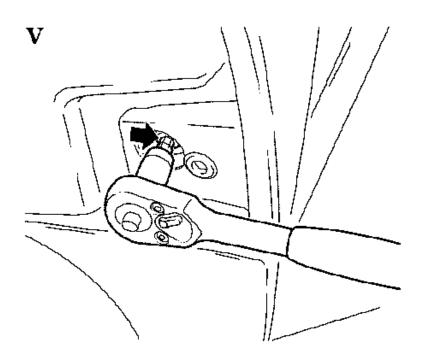
9. Remove screw from wheel housing (pic. V, arrow).

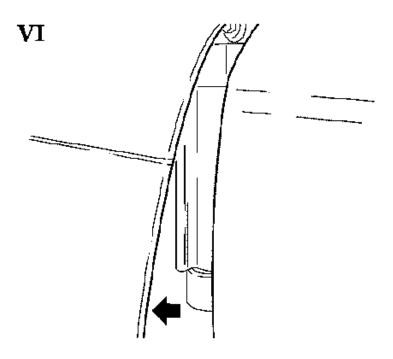
10. Separate front clamshell with a suitable tool from A-pillar and carefully pull open lower rear section to allow access to check spring fixings (pic. VI, arrow).

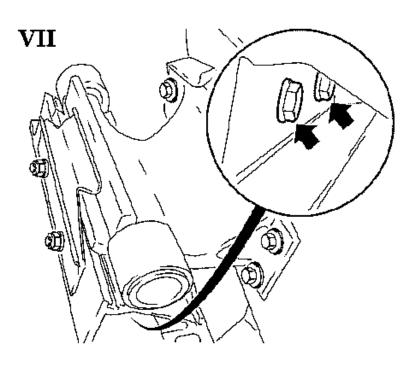
11. Remove check spring (pic. VII), (pic. VII shows door check spring for better view in removed position).

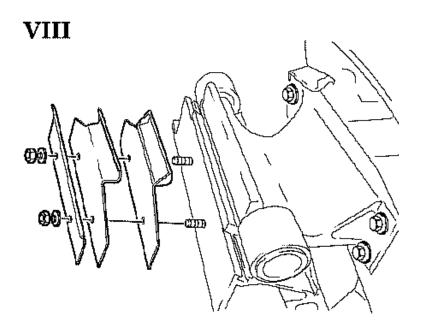
12. Install modified check spring and support spring using original mounting plate (pic. VIII).
