Field Remedy: 1467

Subject: **Rear Lamps - Water ingress**

Speedster 2000...2002 Z22SE

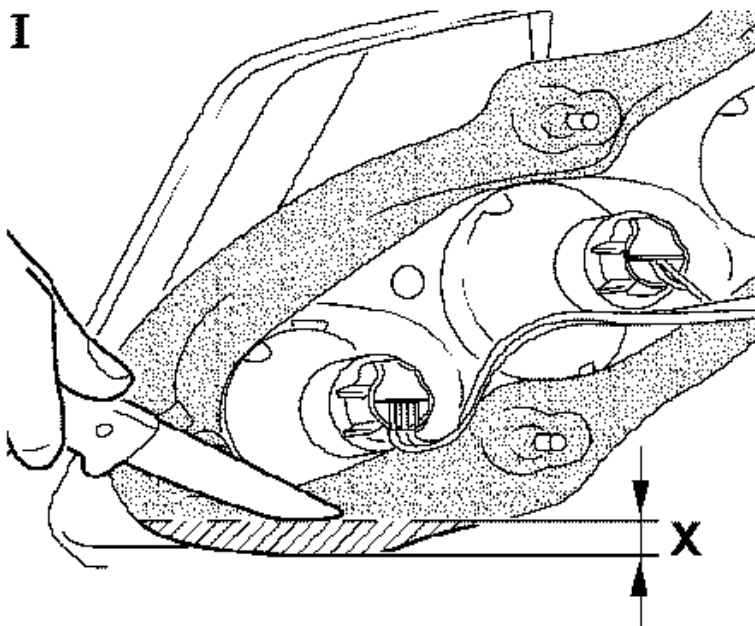
Complaint: Water ingress on rear lamps.

Cause: Poor position of sealing rear light.

1. Remove rear lamps
 - see working procedure "Rear Lamp, Remove and Install", group "N", Service Instruction Speedster.
2. Cut and remove foam rubber section "x" of rear lamps with suitable tool (picture I, X=20 mm).
